memorandum

Re: Sandy Point: South Cape Historical Shore Change Analysis

South Cape Sandy Point
2011 Beach Topography

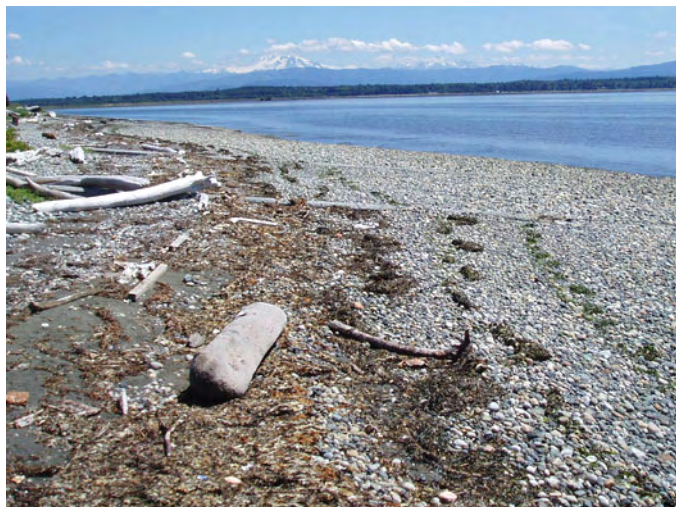
7/7/06 – Concrete groin barely visible above grade

Transect D, near the groin field, has very likely been influenced by the presence of the low concrete groins fields across the beach. The recent trends here have been for moderate erosion. However, this may be an aberration in the data, and the beach may accrete back to near the level of the concrete groin in the future.

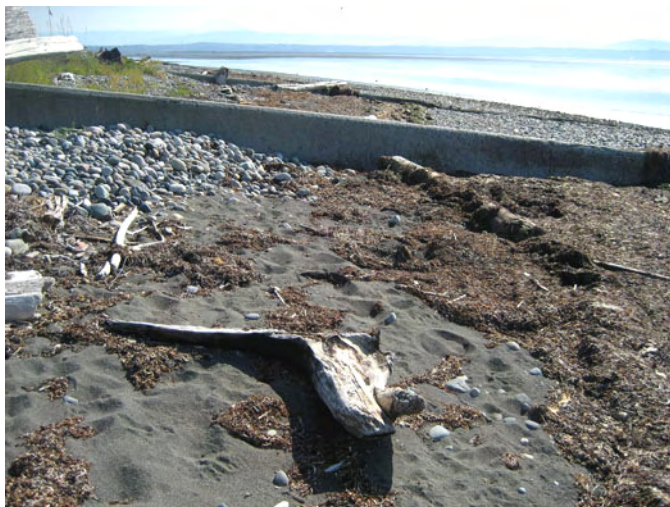
9/8/11 – concrete groin exposed approximately 6" above grade

Erosion and accretion observations for the three transects at South Cape showed two different general trends. Transects B and C, at the western and middle portions of the study area respectively, have steadily eroded since 1962. Total recession between 1962 and 2011 was 45.3 ft and 40.2 ft at +8 ft MLLW for Transects B and C, respectively (Table 2a). Transect D however, has generally remained stable to slightly accretional until 2011 when the shoreline eroded 11.2 ft at +8 ft MLLW relative to the 1962 position. This reversal is also apparent in ground photos taken during the 2006 and 2011 site surveys (Photo Page 1).

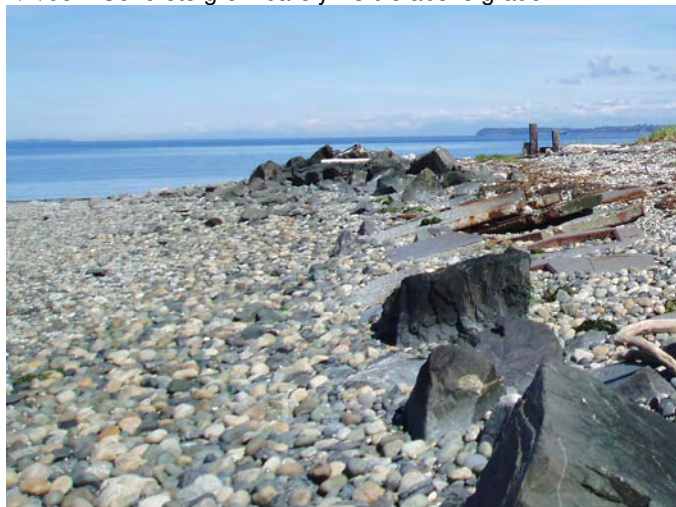
7/7/06 – Rock revetment and concrete debris at west end

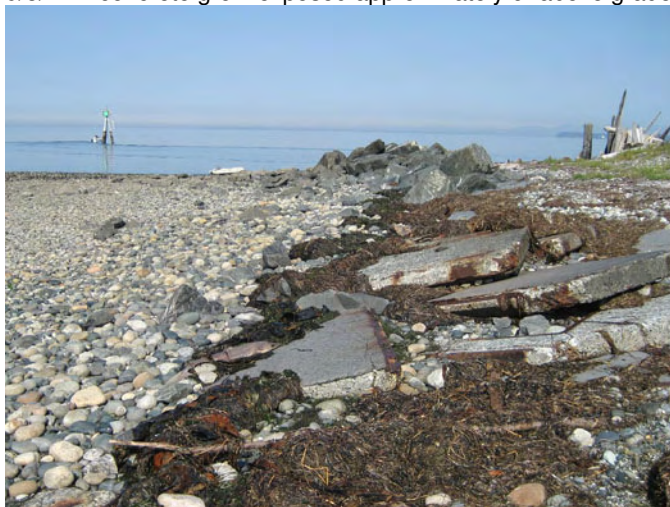
9/8/11 – Same rock revetment and concrete

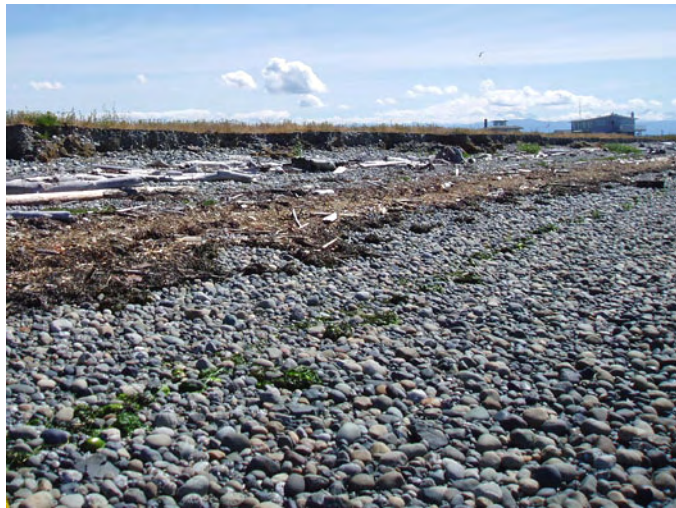
7/7/06 – western area looking east

The upper beachface of South Cape at Sandy Point appeared more stable in the western portion of the survey area, near Transect B (Sheet 1, Photo Page 1). Vegetation was seen growing approximately 20 ft waterward of the low bank/erosional scarp at the edge of the “uplands” throughout much of the survey area in September 2011. Toward the middle and eastern end of the survey area, dunegrass (*Elymus mollis*), Pacific gumweed (*Grindelia integrifolia*), and other herbaceous plants had become established waterward of the historically erosional scarp, and may provide some stability to the beach and bank during storm events. The 2006 surveying followed several high-energy wind storms that occurred at very high water levels. However, note that the 2011 photos were taken at the end of summer and the 2006 photos were from early summer. Surface sediments were generally cobbly pebble near the bank toe trending toward pebbly cobble at the mid and lower beachface. At the eastern end of the survey area a 10–15 ft wide band of pebbly sand was seen near MHHW.

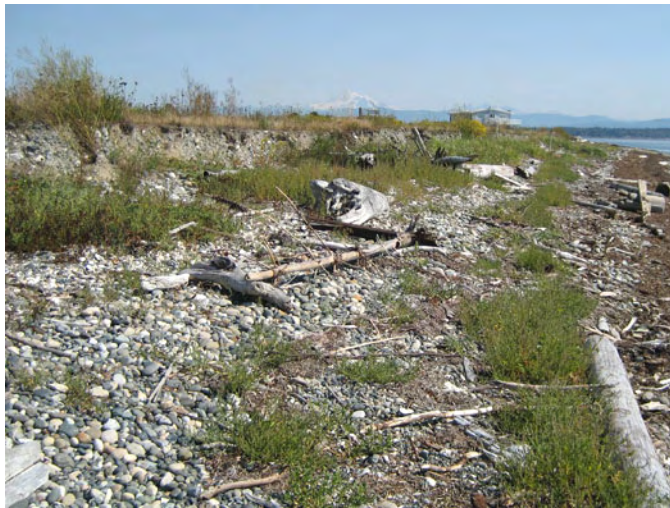
9/8/11 – same area showing vegetation
